Manhole Inspection Summary

Manhole # S13A__013MH

Insp Date: 1/21/09 11:55 AM

Location Address: **701 POPLAR GROVE**

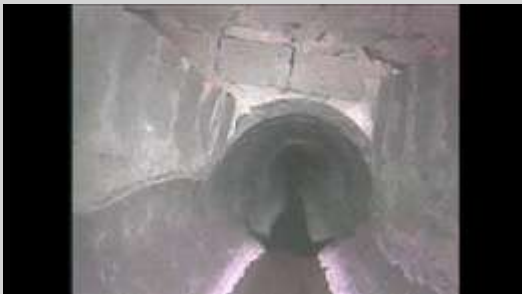
6 O'Clock Inflow

Pipe Height: **8.4** (in.) Rod and Bar (Angled)
Pipe Material: **Clay** ☐ Pipe Lined
Invert Depth: **6.90** (ft.) Flow Characteristics: **Slow**
Deposits: ☒ None ☐ Mud ☐ Sludge ☐ Debris ☐ Grease
Silt Depth: (in.) Deposits Extent:
Infiltration: **None** Pipe Seal Cond: **Sound**
